## Reconsidering the “MR Unsafe” breast tissue expander with magnetic infusion port: A case report and literature review

Rami Dibbs<sup>1</sup>, Bozena Culo<sup>2</sup>, Ravi Tandon<sup>3</sup>, Hugo St. Hilaire<sup>3</sup>, Frank G. Shellock<sup>4</sup>, Frank H. Lau<sup>3</sup>

Case Report

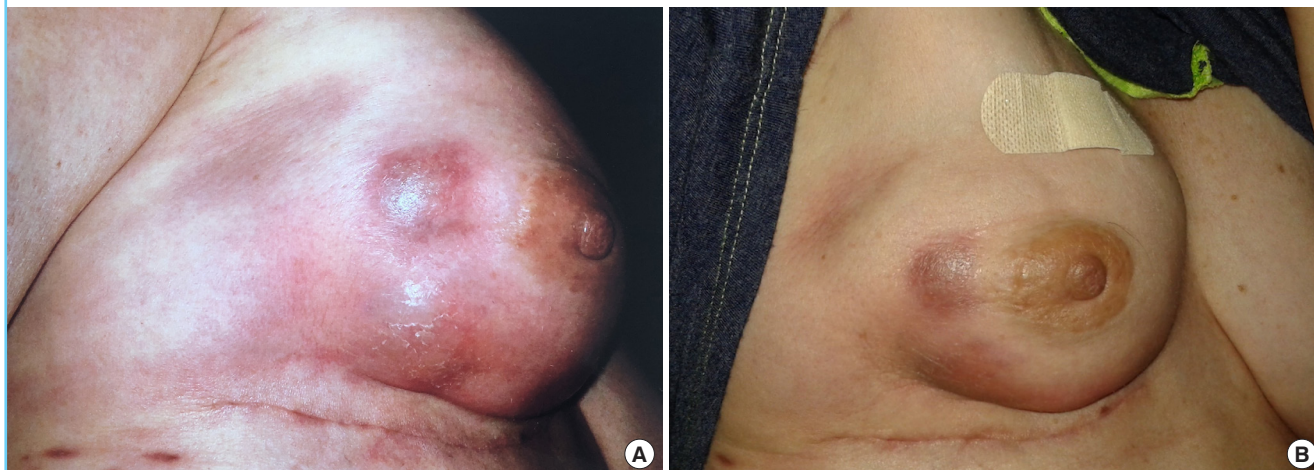
**Fig. 1. Expander loss following vehicular accident and MRI**

Five days later, the patient presented to the emergency department with right breast pain. On physical exam, the breast had two lesions, 2 cm in diameter, and associated erythema and swelling. She was diagnosed with cellulitis and was prescribed clindamycin. The cause of the cellulitis was likely associated with the trauma sustained from the traffic accident. The patient presented to her plastic surgeon the following day who also noted right inframammary fold erythema and the small lesions (Fig. 1). The saline in the TE was removed. Despite these maneuvers, the right breast continued to worsen and by 3 weeks post-MRI, the patient had impending TE exposure and required

(A, B) Clinical photographs showing inframammary fold erythema and blistering of the patient's right breast following motor vehicle collision with the patient as a pedestrian and subsequent magnetic resonance imaging (MRI).

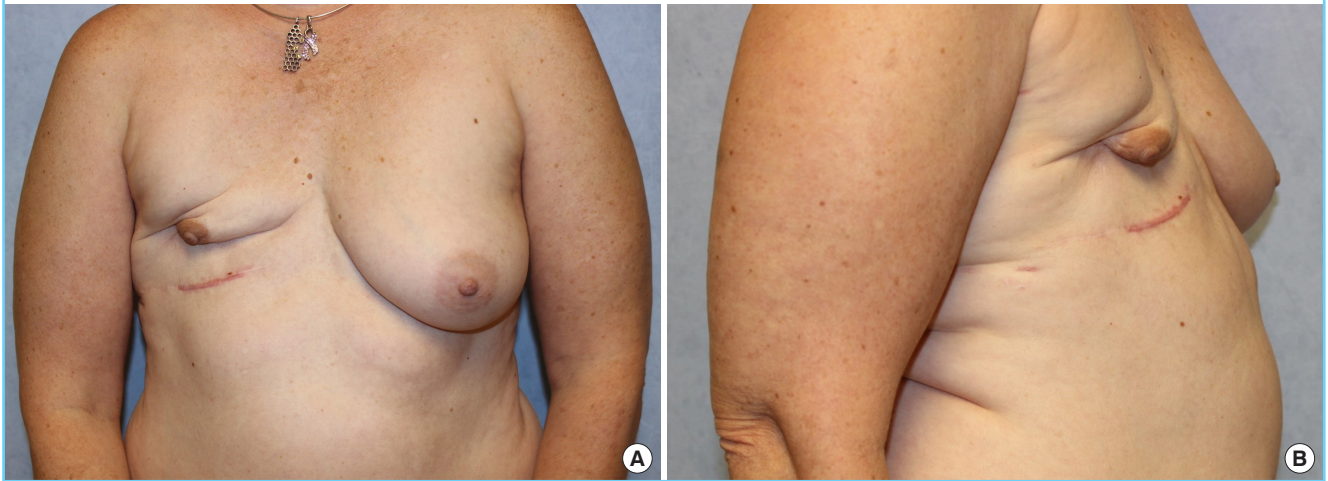
**Fig. 2. Acquired breast deformity following tissue expander explantation**

Clinical photographs demonstrating the patient's asymmetric chest after explantation of tissue expander with a magnetic infusion port. (A) Front view. (B) Side view.

explantation (Fig. 2). Intraoperatively, neither purulence nor fluid collection were present. One year later, the patient successfully underwent breast reconstruction with stacked deep inferior, epigastric artery perforator flaps (Fig. 3). At the time of autologous reconstruction, extensive scar tissue was noted at the mastectomy skin flaps, pectoralis muscle, periosteum, and encasing the internal mammary vessels.

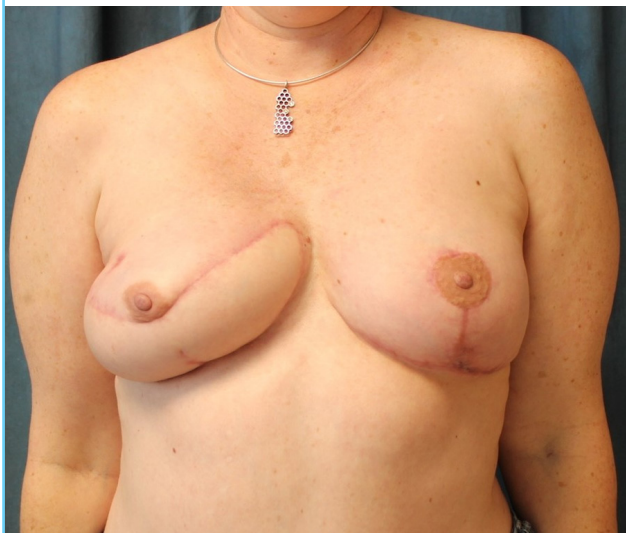
**Fig. 3. Delayed breast reconstruction using stacked DIEP flaps**

Patient after undergoing successful right breast reconstruction with stacked deep inferior epigastric artery perforator (DIEP) flaps.

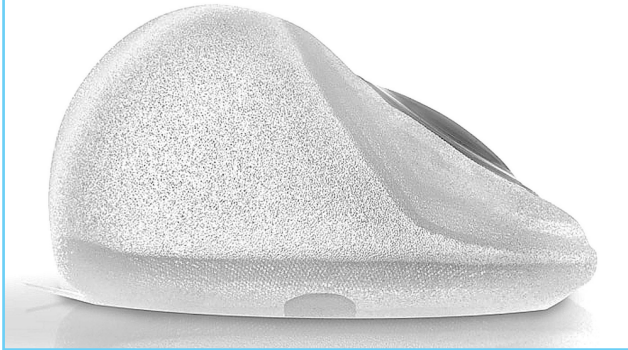
**Fig. 5. The ARTOURA Breast Tissue Expander**

Note the position of the magnetic infusion port and that it is covered with nonmetallic, nonconducting material, insulating and isolating it from the patient's tissue. Figure supplied by Mentor Worldwide LLC (Irvine, CA, USA).

A breast TE with a magnetic port is composed of a bladder with an outer shell made from silicone and an internal metallic infusion port to permit saline injections for implant expansion. A permanent magnet is incorporated into the implant to facilitate location of the port. Of note is that the metallic component is isolated and insulated from the patient by a layer of nonmetallic, nonconducting material (Fig. 5). Since the metallic component is small and has no direct contact with the patient's tissues, heating is not a realistic concern.
