Safe Scanning, but Frequent Artifacts Mimicking Bradycardia and Tachycardia During Magnetic Resonance Imaging (MRI) in Patients with an Implantable Loop Recorder (ILR)

J. Rod Gimbel, M.D.,* Jamal Zarghami, M.D.,† Christian Machado, M.D.,† and Bruce L. Wilkoff, M.D.‡

A.N.E. 2005;10(4):404-408

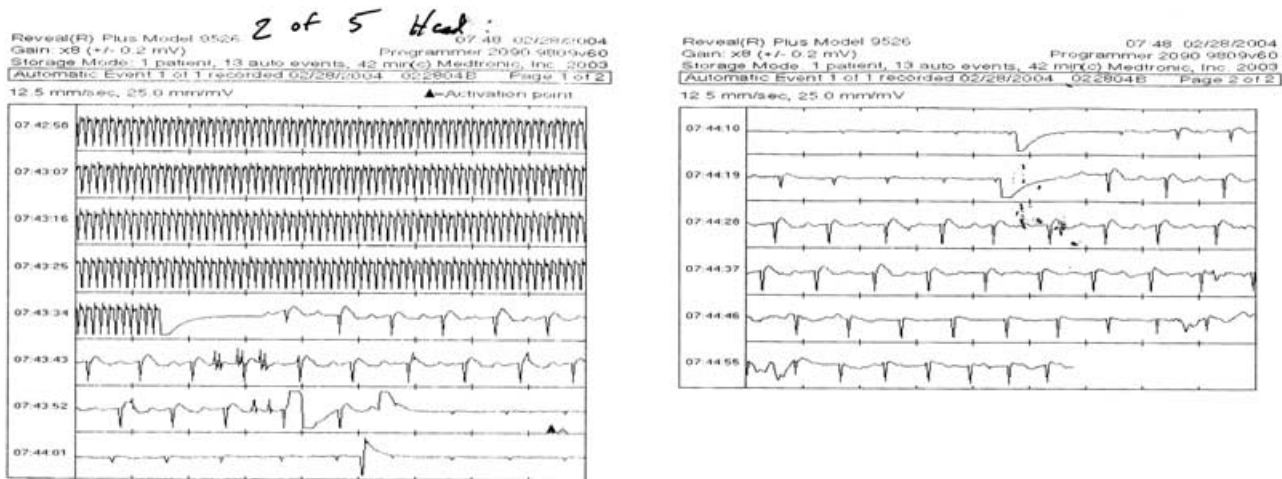
During seven of the 11 MRIs, the ILRs automatically recorded events satisfying the detection criteria for an arrhythmia. Review of the individual events recorded during MRI demonstrated multiple artifacts mimicking both rapid wide and narrow complex tachycardias as well as asystole and complete heart block. Artifacts mimicking a narrow complex tachycardia were most common; seven of seven ILR patients recording at least one event during MRI recorded a narrow complex rhythm artifact. Two of the ILRs recorded both narrow complex tachyarrhythmias and bradyarrhythmias (Figs. 1 and 2). As previously reported, during shoulder MRI, 1 patient recorded both a wide and narrow complex rhythm.⁵ Recorded artifacts were noted after patients underwent a variety of imaging studies at 1.5 T including four of seven cranial scans, one shoulder scan, and both lumbar spine scans. Artifacts were recorded during scans using transmit-receive coils (four of seven cranial scans) and scans that did not use transmit-receive coils (shoulder scan and both lumbar spine scans). Marked signal attenuation of the native QRS was also recorded during MRI mimicking complete heart block (Fig. 1).

Figure 1. Artifact mimicking narrow complex tachycardia. Marked signal attenuation mimicking complete heart block. Both occurred during cranial MR scanning.

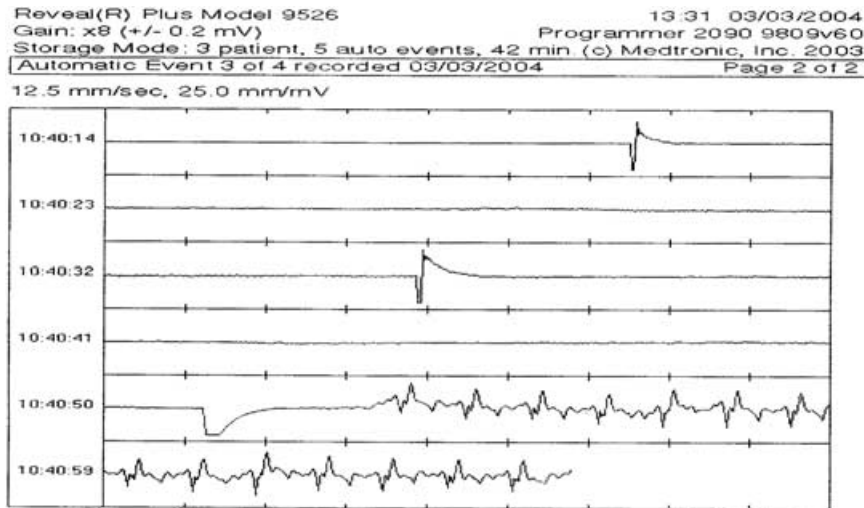
Figure 2. Prolonged episode of asystole recorded by ILR during lumbar spine MRI.

eventual return of signal fidelity. During a lumbar spine scan, one patient's ILR stored an event mimicking prolonged asystole with a similar abrupt loss of signal as described by Chrysostomakis et al. and Vlay. We were unable to determine if this was caused by the RF application or the gradient magnetic field applied during MR scanning. It seems reasonable, however, that the prolonged intense EMI present in the MR suite could overwhelm the sense amplifiers in the device producing such an artifact. No patient recalled a sensation of electrostatic discharge during MRI.
